ENVIRONMENTAL ASSESSMENT REPORT

**120th and Peoria Streets
Chicago, Illinois**

November 1993

**Simon Hydro-Search, Inc.
3334 Richmond Avenue, Suite #200
Houston, Texas 77098
(713) 520-7667**

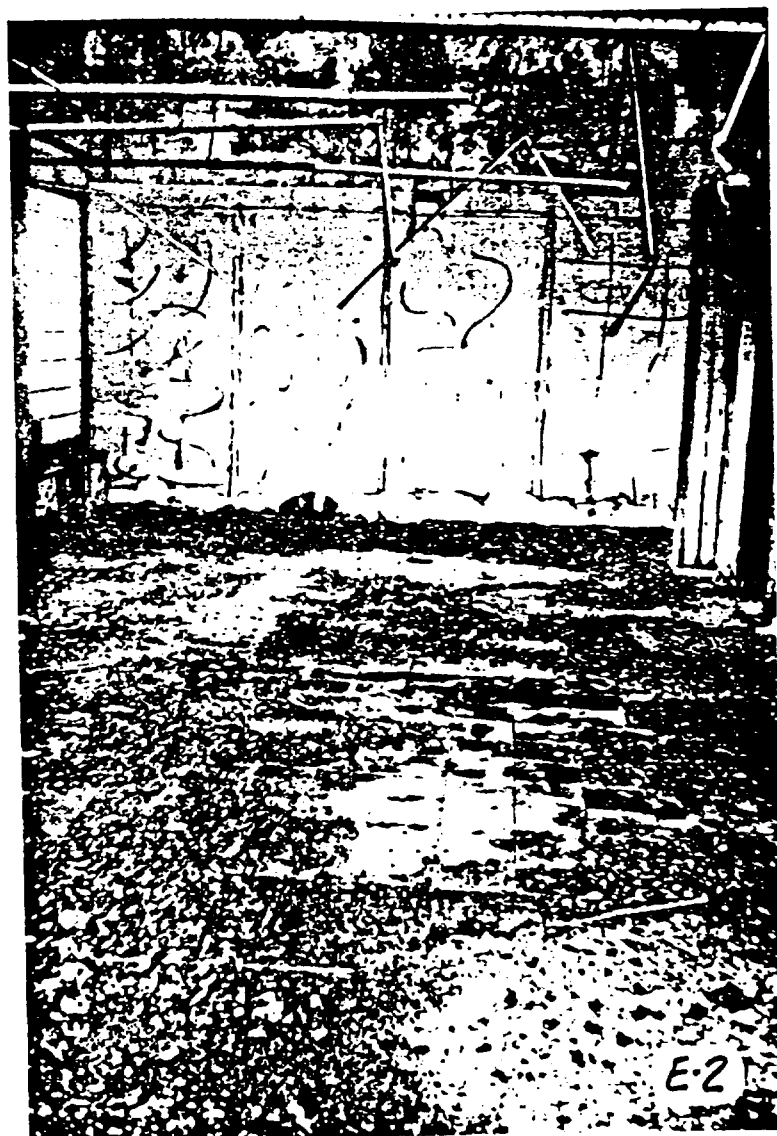
Nos. 3 & 4: Mill Building, Basement Crawl Space, Pipe Insulation
Asbestos Content: 30-40% Chrysotile (Two Types)
Estimated Length: <10 Linear Feet in Crawl Space

Note: Basement Area not inspected, inaccessible.
